MTB TRAILS MASTER PLAN

SMITHERS, BC

TRAILHOLISTICS.COM

Trail Holistics was hired by the Smithers Mountain Bike Association (SMBA) to assess trails in the following areas; 1) Bluff Trail Network, 2) the Piper Recreational area, 3) Ptarmigan Recreational trails, and 4) the Backdoor trail. This assessment includes an inventory of all technical trail features and wood structure, updated classification of trails with specific prescriptions to repair and improve trails and trail infrastructure.

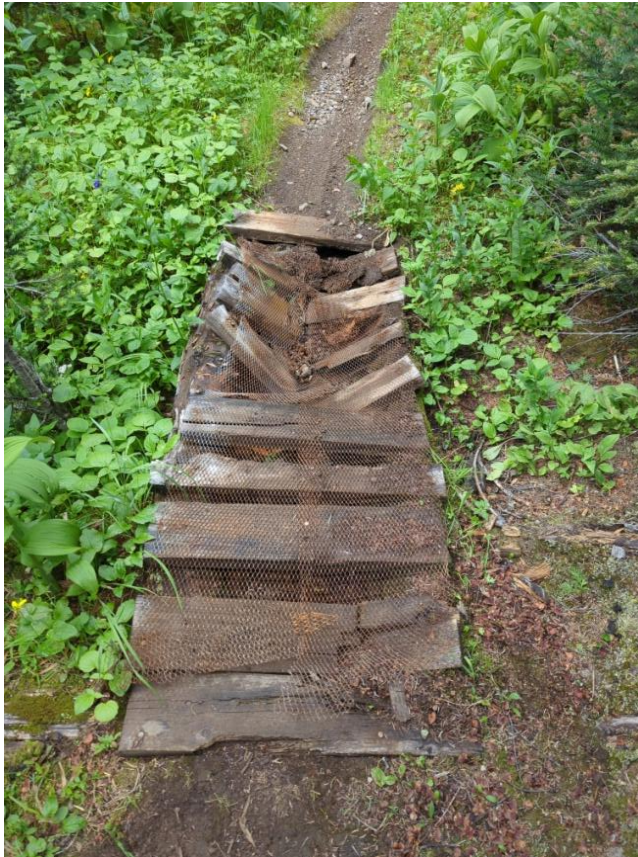
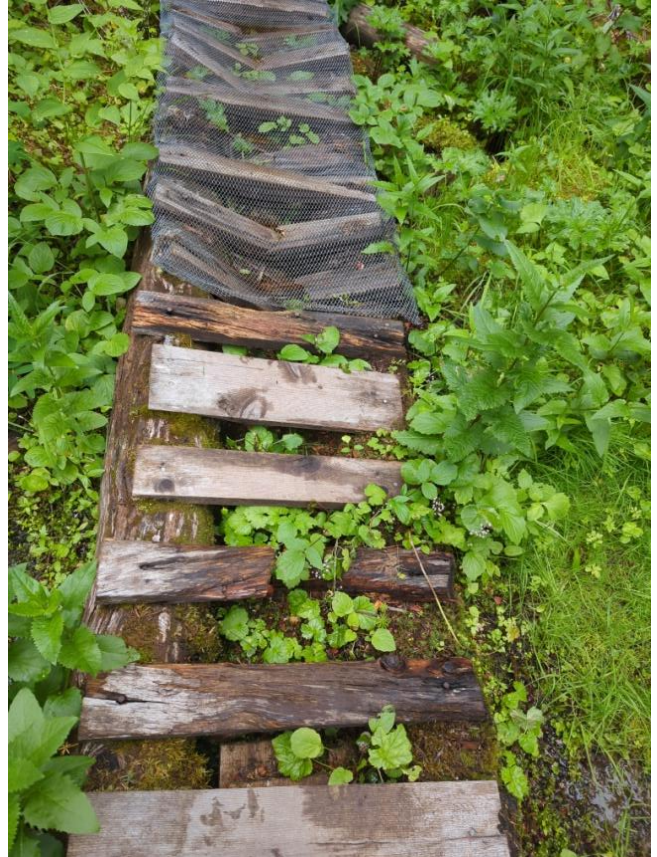
Due to age and condition, many of the wood structures on Backdoor trail are in immediate need of replacement.

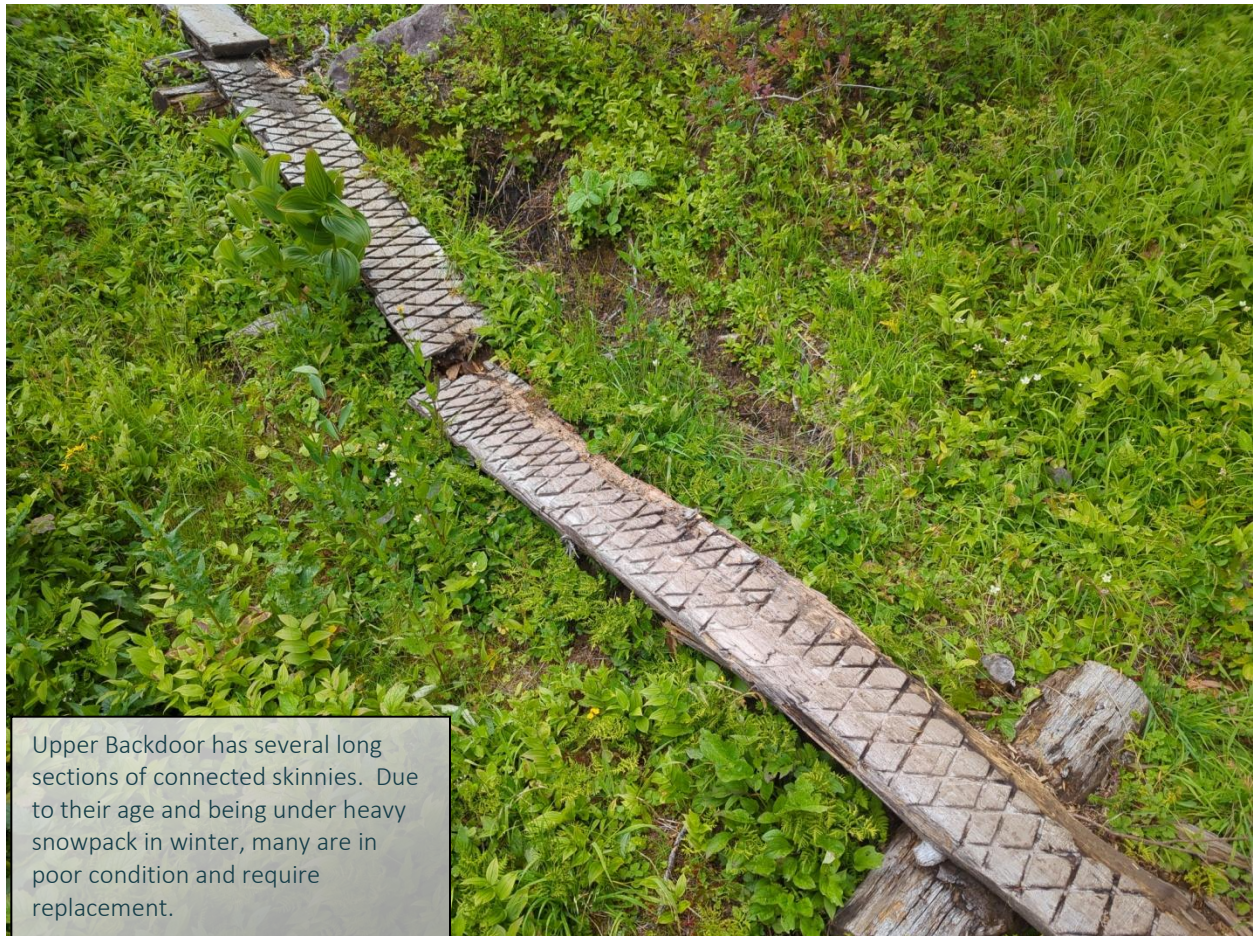
Upper Backdoor has several long sections of connected skinnies. Due to their age and being under heavy snowpack in winter, many are in poor condition and require replacement.

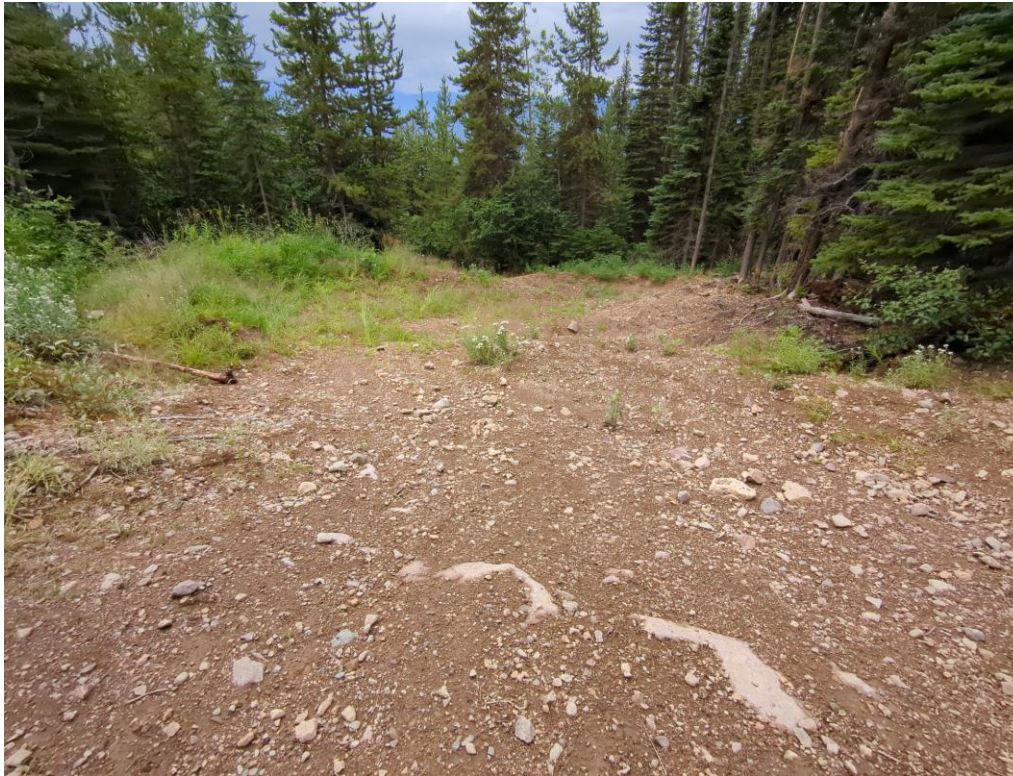
This section on Pay Dirt (REPAIR POI 14) is in a severely degraded state. Open to the elements with high aggregate content of site soils, the result is exacerbated erosion and clogged drainages. The ideal solution would be to realign this section into the forest to utilize tree canopy deflection of the elements and improved tread composition. This should result in improved long term sustainability and an improved user experience.

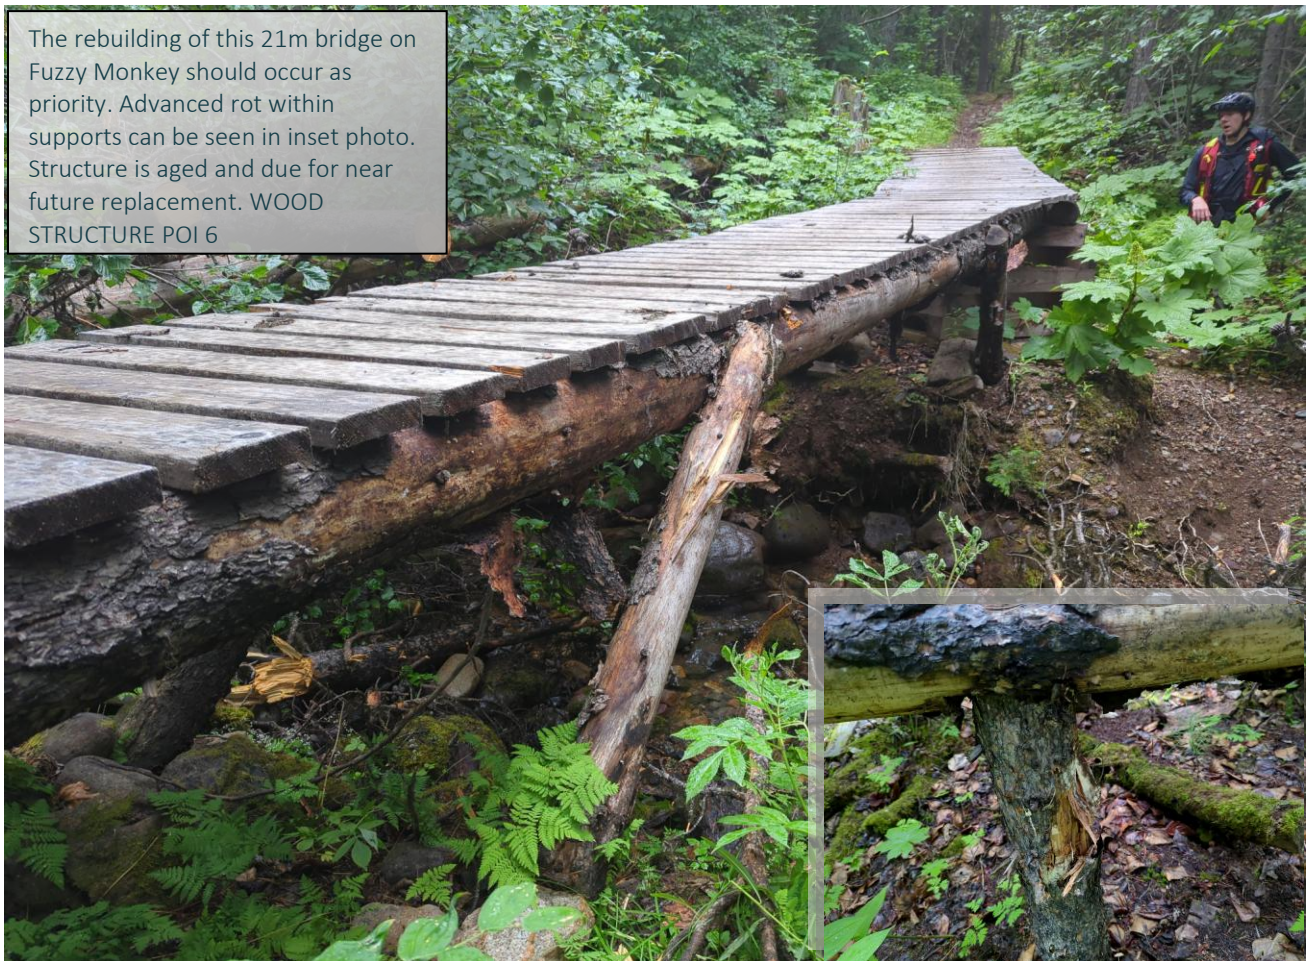
The rebuilding of this 21m bridge on Fuzzy Monkey should occur as priority. Advanced rot within supports can be seen in inset photo. Structure is aged and due for near future replacement. WOOD STRUCTURE POI 6

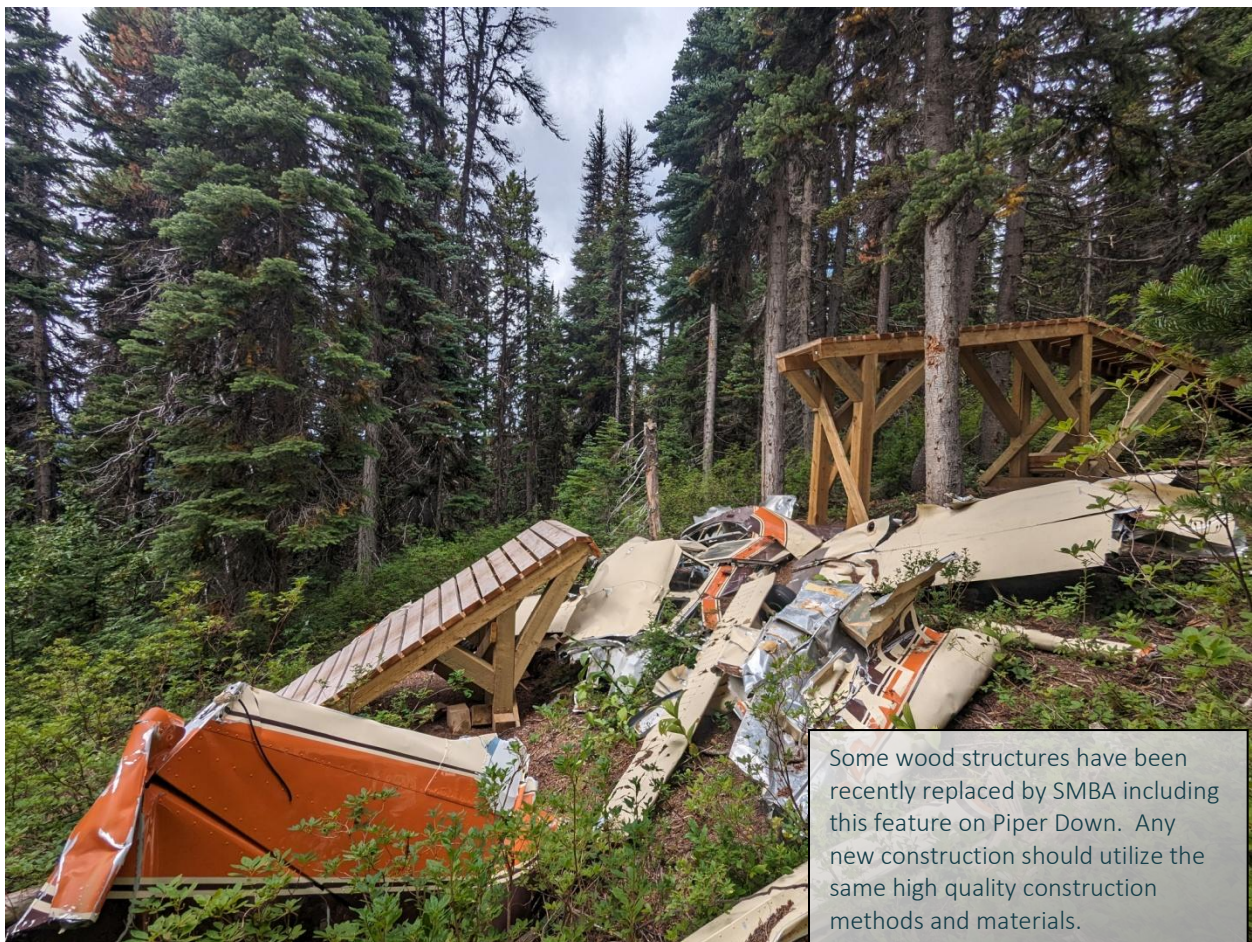
Some wood structures have been recently replaced by SMBA including this feature on Piper Down. Any new construction should utilize the same high quality construction methods and materials.

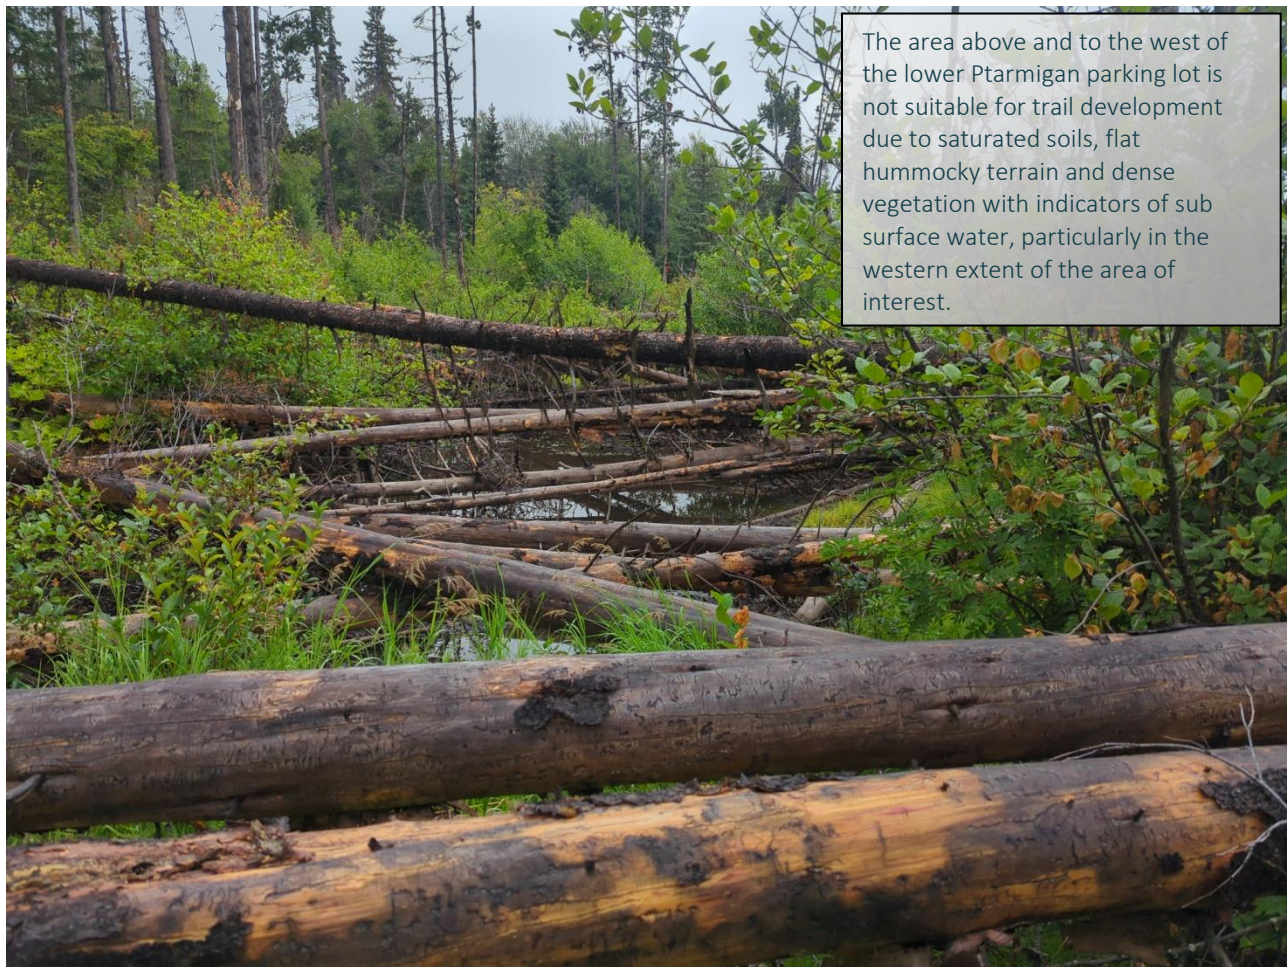
The area above and to the west of the lower Ptarmigan parking lot is not suitable for trail development due to saturated soils, flat hummocky terrain and dense vegetation with indicators of sub surface water, particularly in the western extent of the area of interest.
