MTB TRAILS MASTER PLAN

SMITHERS, BC

TRAILHOLISTICS.COM

Trail Holistics was hired by the Smithers Mountain Bike Association (SMBA) to assess trails in the following areas; 1) Bluff Trail Network, 2) the Piper Recreational area, 3) Ptarmigan Recreational trails, and 4) the Backdoor trail. This assessment includes an inventory of all technical trail features and wood structure, updated classification of trails with specific prescriptions to repair and improve trails and trail infrastructure.

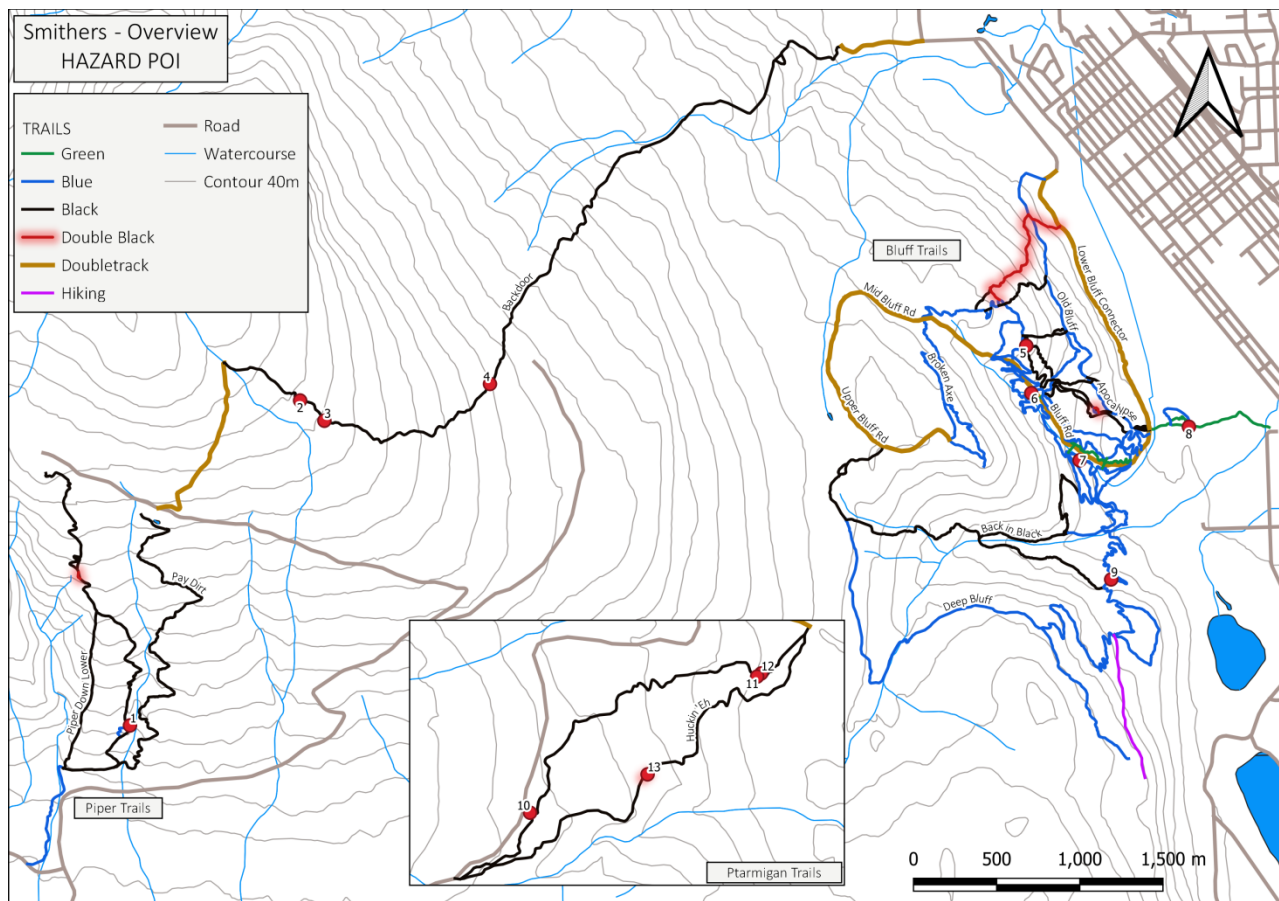
HAZARD POI

POI	DESCRIPTION
1	fall hazard beside Heckle Rock slab. critical fall potential. requires load bearing testing for entire length of fence and fencing expansion at run out where critical fall exposure exists.
2	broken decking in boardwalk. See WOOD STRUCTURE POI 10
3	broken decking in boardwalk. See WOOD STRUCTURE POI 11
4	broken skinny downramp on mainline, only option. See TTF POI 86
5	large TTF at entry of Shining - aged, decrepit, supports missing. See TTF POI 201
6	critical load bearing posts rotted, off camber decking. bridge should be closed and rebuilt. See WOOD POI 55
7	tree hanging over trail. trail requires 2.4m high clearance as per WTS - remove.
8	fast high speed section DH into blind junction. High traffic entry area/multiple trail convergence. deactivate with logs and/or fencing with signage if required.
9	short cut trail bissects MS at multiple points resulting in blind exits at speed. At this point it exits at high speed onto MS, at jump entrance. deactivate trail/close to DH bike traffic

10	high speed corner coming out of large table top. clear fall zone outside turn to 1.5m.
11	wood ramp bolted into rock face requires upgrades to structure and fencing due to age, condition and critical fall exposure. See TTF POI 153
12	fall protection fence aged and unstable. replace. fall hazard >6m h. cribbing in trail is rotten, replace.
13	merge from easy bypass into drop run out: high risk of collision. choke off upper merge point from easy bypass

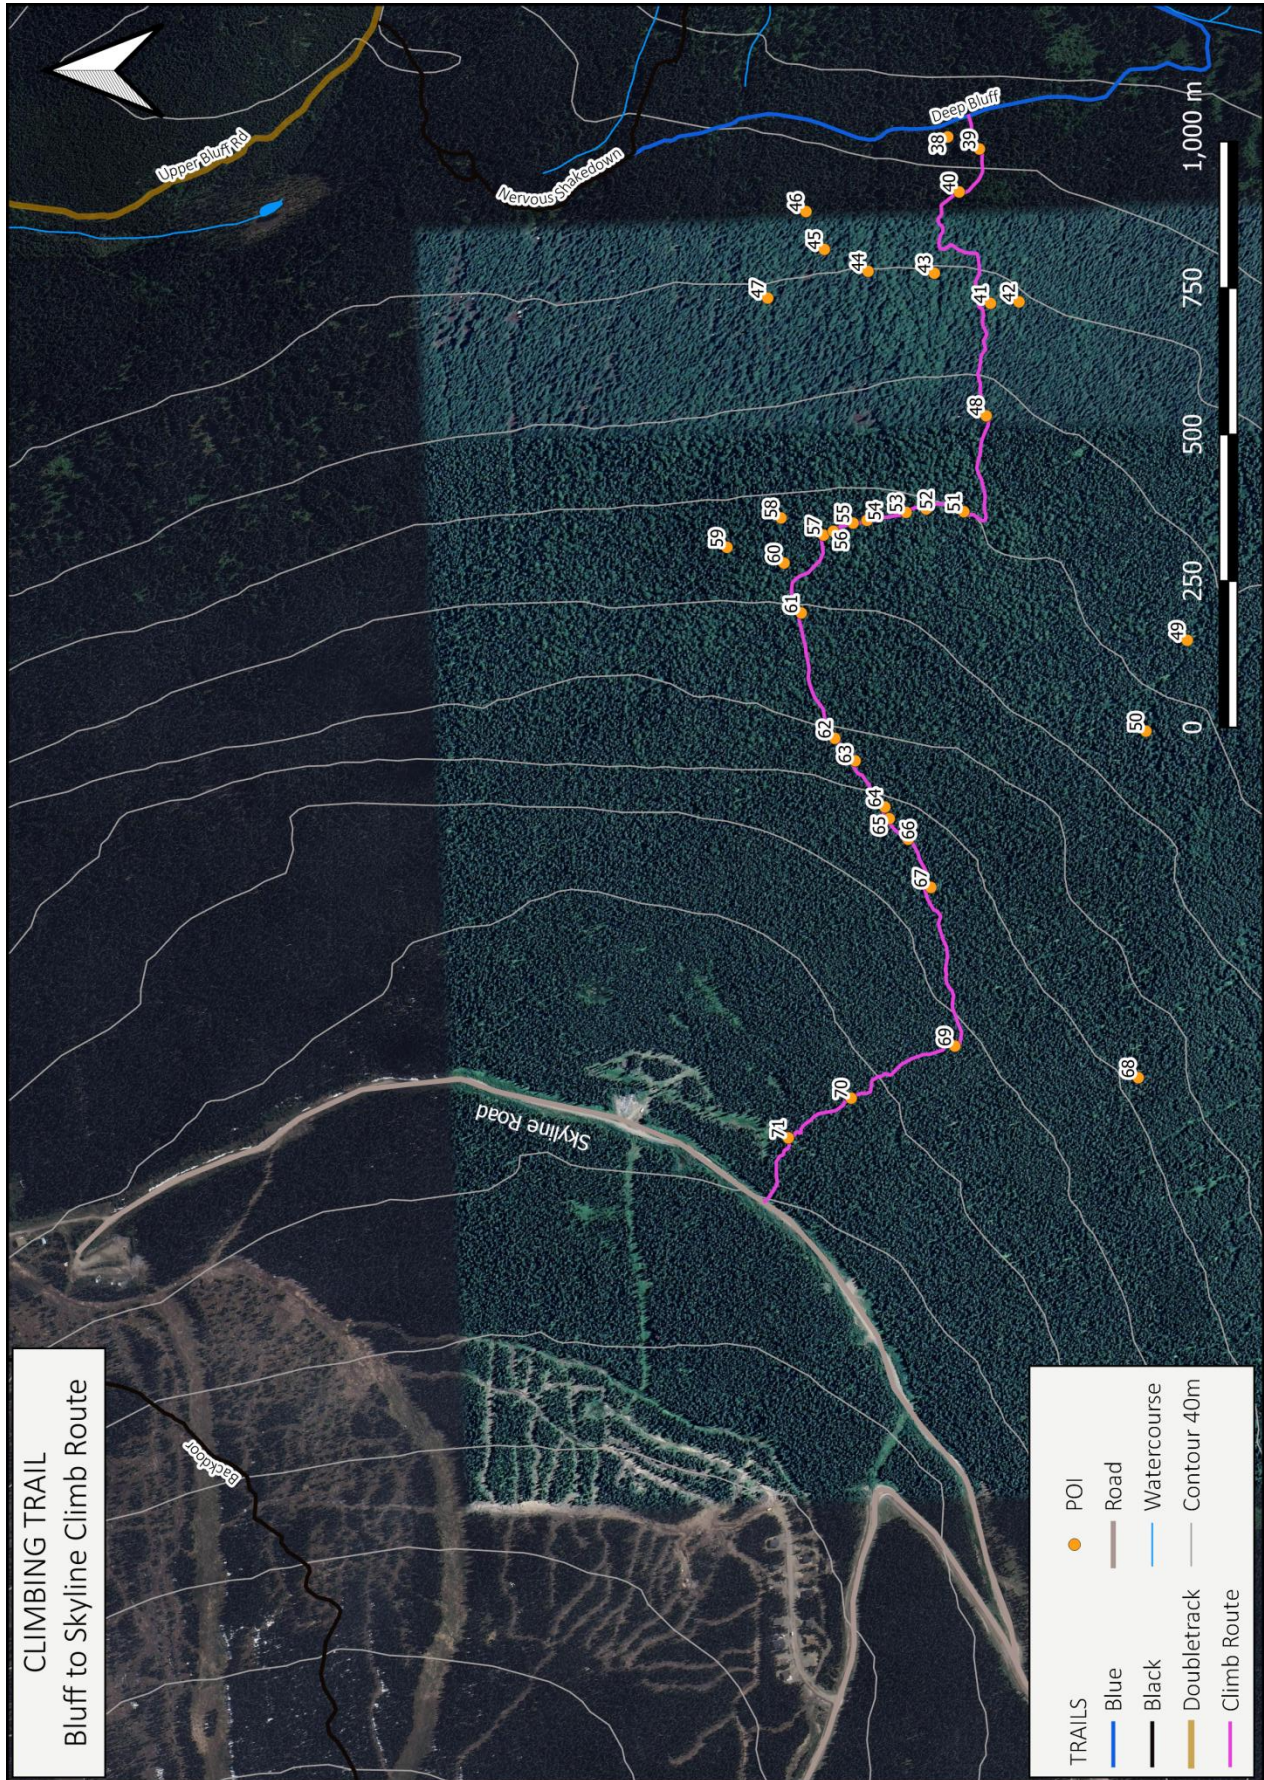
3.14 MAP: SKYLINE CLIMBING ROUTE

POI	TYPE	DESCRIPTION
38	watercourse	ephemeral channel
39	slope	25 - 30% slope. good terrain, well drained soils. stay to south of draw
40	draw	ephemeral draw
41	sound	good slope/drainage
42	saturated	avoid as southern border of corridor
43	watercourse	ephemeral
44	watercourse	ephemeral
45	saturated	flat, hummocky
46	flat	hummocky
47	slope	low grade hummocky bad vegetative indicators
48	flat	terrain plateaus. well drained soils
49	watercourse	wide drainage course
50	saturated	dense devils club, poorly drained soils, large area below perched wetland
51	bridge	bridge 5m over ephemeral flow. 3' minimum width of decking.
52	traverse	side hill traverse on 20% slope moderately drained soils
53	boardwalk	>15m boardwalk over ephemeral draw. Minimum 2' width decking.
54	sidehill	30% slope moderately drained soils
55	boardwalk	boardwalk 5m long thru devils club. Minimum 2' width decking.
56	soil	2" organics, high quality loam B horizon.

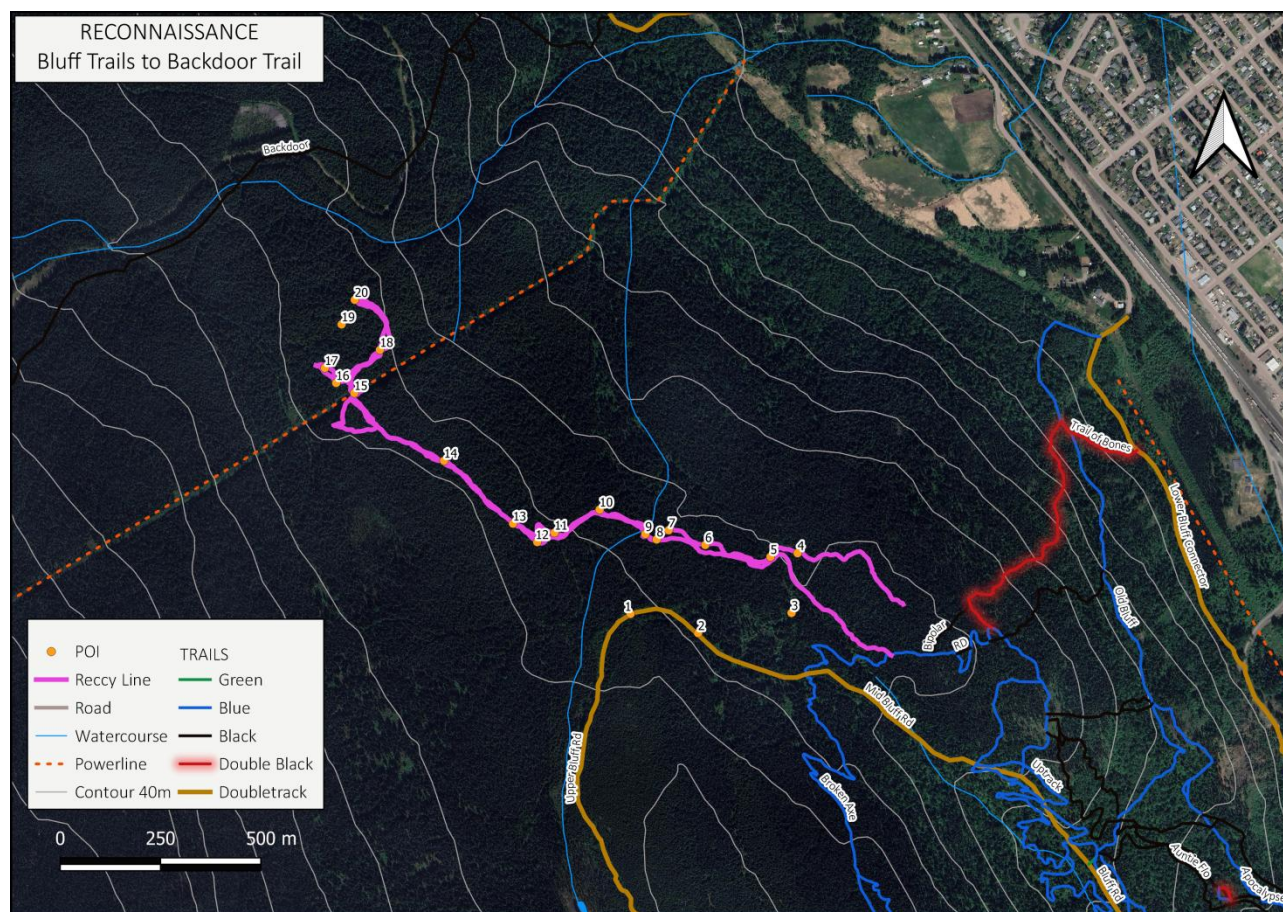
POI	TYPE	DESCRIPTION
1	saturated	road is muddy, 18% sustained grade, channelled. deep veg on low side indicates saturated soils.
2	saturated	
3	dense	flat and saturated, dense veg
4	slope	flat and duffy 70m
5	boardwalk	20m thru swamp
6	old road	
7	slope	20% slope
8	bridge	4m bridge reqd over ephemeral creek
9	bridge	7m bridge reqd over ephemeral flow
10	road	double track road travels upwards >15%
11	slope	30% mature well spaced second growth trees
12	turns	quality slope 30 - 40% gradient
13	dirt	quality dirt, easily accessible
14	forest	forest changes to dense regen
15	boardwalk	saturated soils under powerlines. >10m boardwalk approximately
16	bridge	bridge reqd - 5m over creek
17	saturated	flat hummocky saturated
18	bridge	10m bridge required, steep 'fluted' terrain. challenging crossing
19	saturated	flat, saturated, dense windthrow
20	windthrow	dense wind throw throughout area

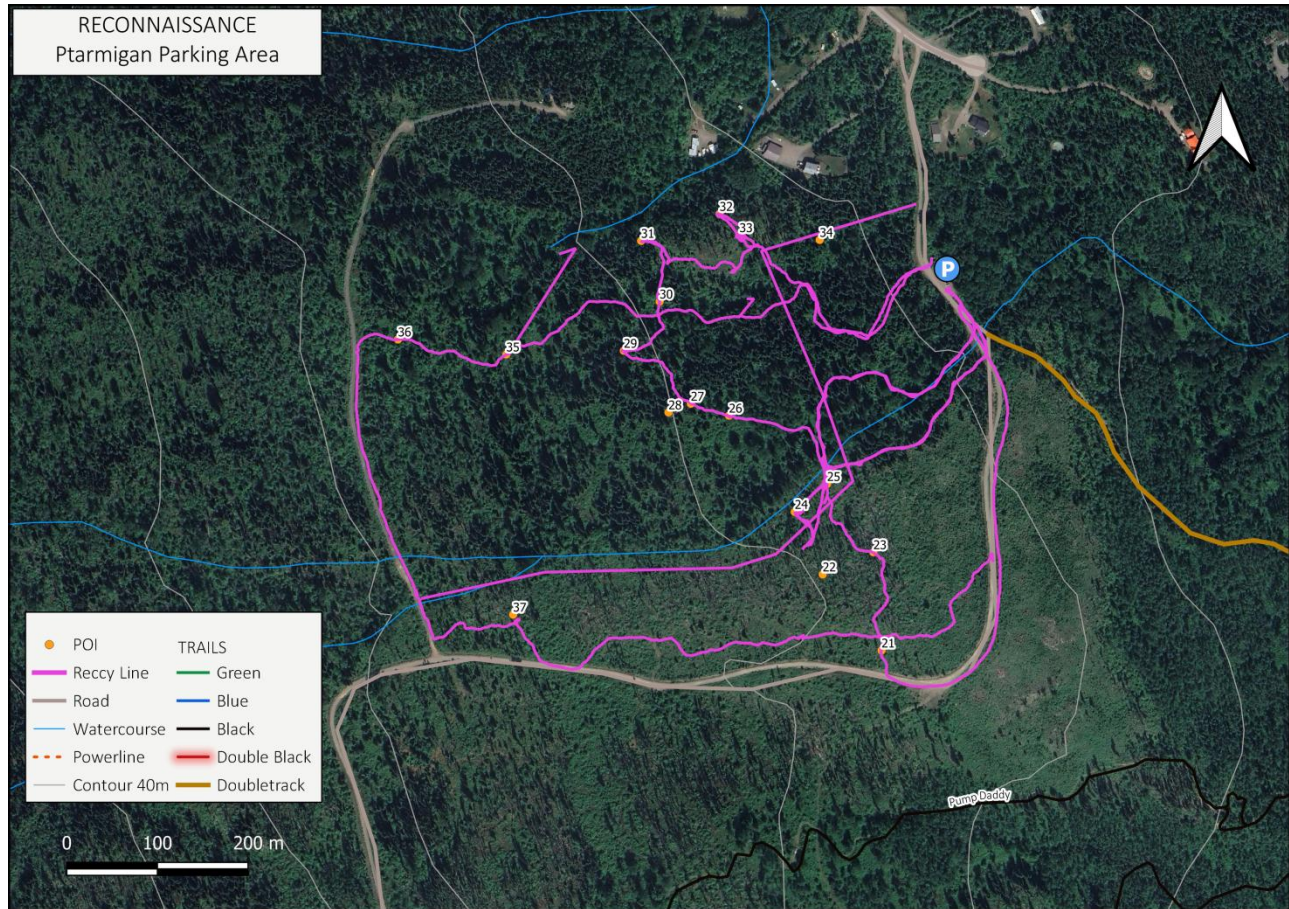
POI	TYPE	DESCRIPTION
21	potential	dry ground, low grade slope +/- 15%
22	flat	flat and log filled
23	low lying	natural bowl
24	draw	dense veg
25	flat	flat, low lying, dense veg
26	slope	low grade, dense veg, 5%
27	slope	low grade 5%
28	slope	slight slope <5%
29	flat	devils club, flat, poorly drained
30	flat	poor drainage
31	cliff	15m edge falls into drainage basin
32	steep	bluff edge falls away NE
33	open	open forest
34	low spot	poor drainage
35	dense	flat, dense veg, poor drainage
36	veg	devils club, dense veg
37	slope	low grade, well drained 10%

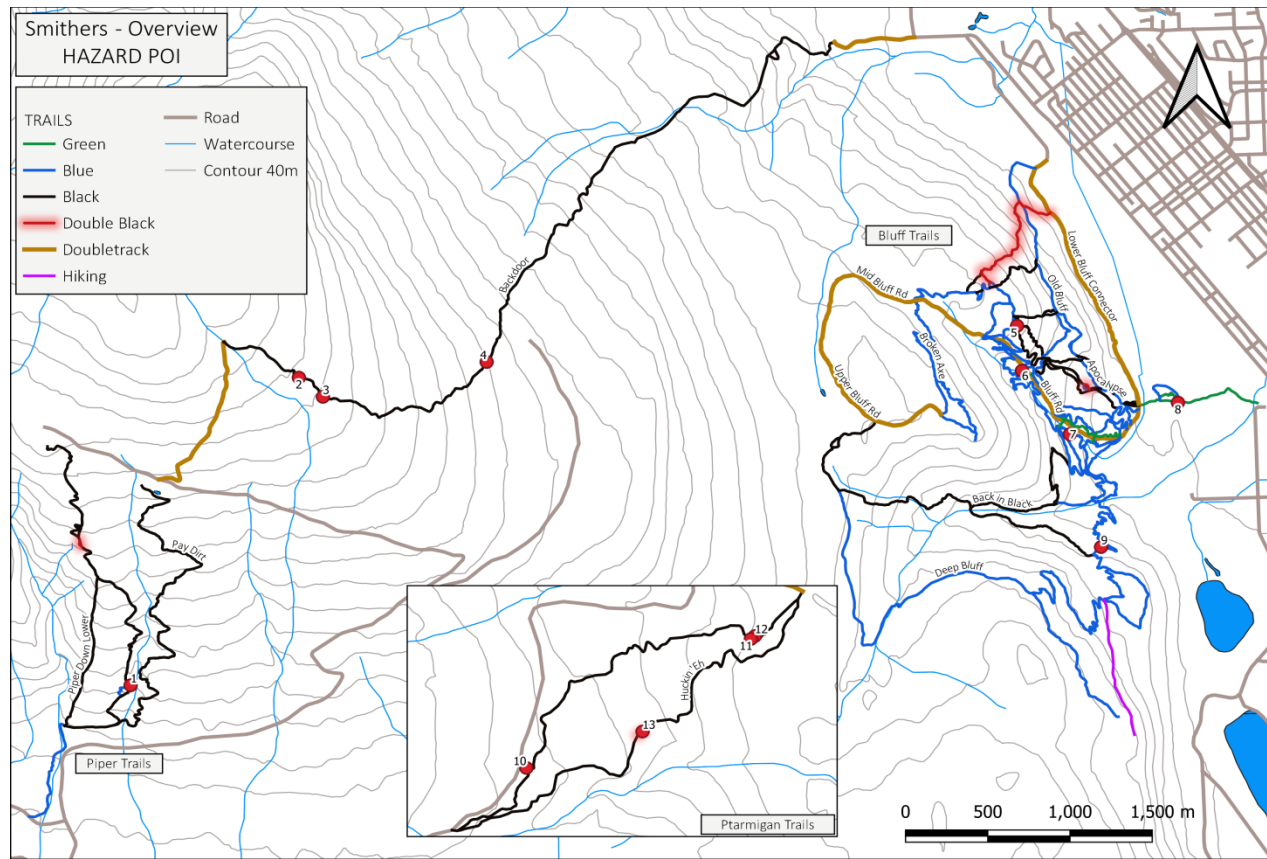
HAZARD POI

POI	DESCRIPTION
1	fall hazard beside Heckle Rock slab. critical fall potential. requires load bearing testing for entire length of fence and expansion at run out where critical fall exposure exists.
2	broken decking in boardwalk. See WOOD STRUCTURE POI 10
3	broken decking in boardwalk. See WOOD STRUCTURE POI 11
4	broken skinny downramp on mainline, only option. See TTF POI 86
5	large TTF at entry of Shining - aged, decrepit, supports missing. See TTF POI 201
6	critical load bearing posts rotted, off camber decking. bridge should be closed and rebuilt. See WOOD STRUCTURE POI 55
7	tree hanging over trail. trail requires 2.4m high clearance as per WTS - remove.
8	fast high speed section DH into blind junction. High traffic entry area/multiple trail convergence. deactivate with logs and/or fencing with signage if required.
9	short cut trail bissects MS at multiple points resulting in blind exits at speed. At this point it exits at high speed onto MS, at jump entrance. deactivate trail/close to DH bike traffic

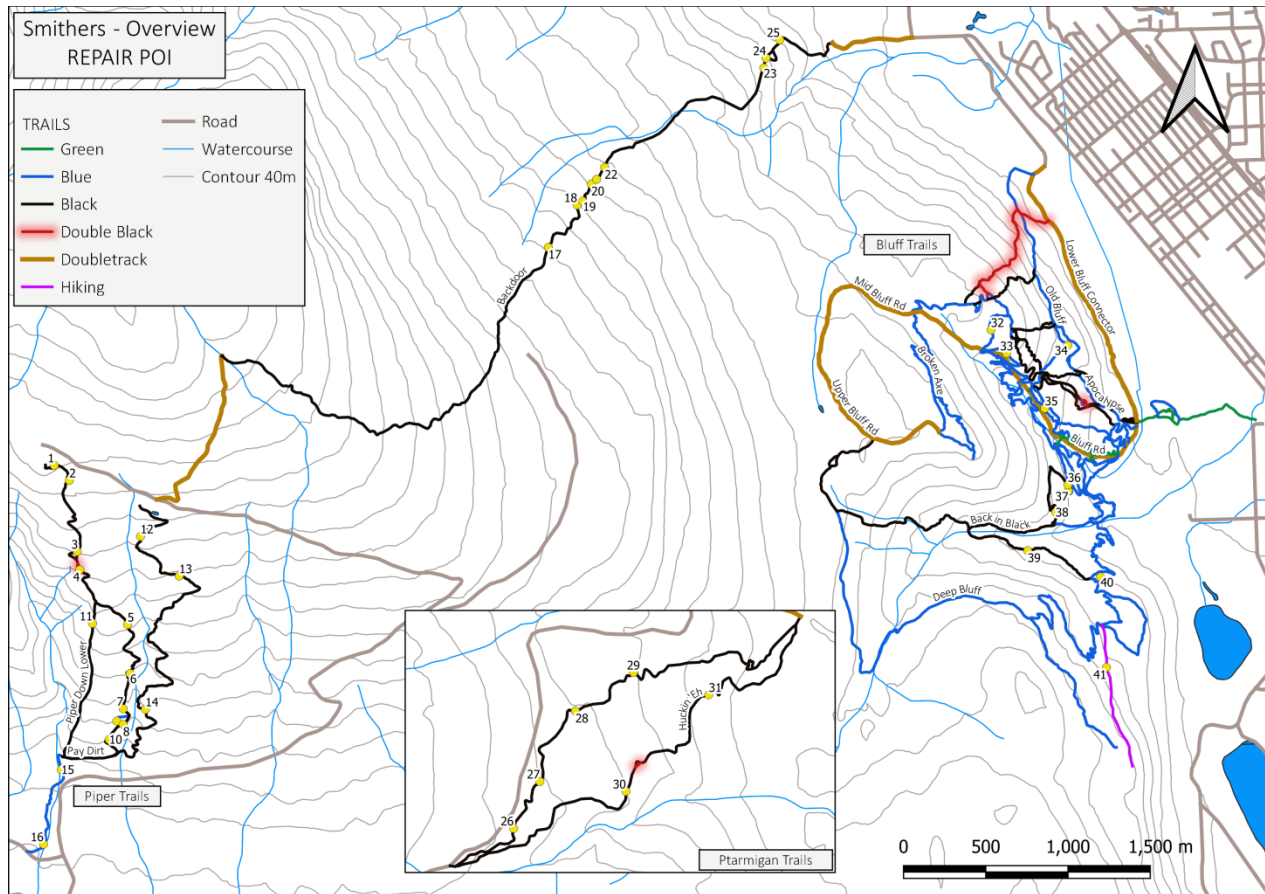
REPAIR POI

POI	DESCRIPTION
1	30% for 40 m. minor scouring of tread from coursing water. implement drainage/grade reversals as required. monitor
2	catch berm. requires fill. monitor wood backing, remove as determined and backfill with rock/dirt.
3	erosion/trenching/rotten wood. catch berm requires rebuild and backfill. cribbing before catch berm requires replacement and backfill. water dispersion required on bypass.
4	rotten crib log at merge point. replace.
5	add waterbars/swales/drainage where possible through sustained 15 % sustained descent +/- 50m.
6	berm. Punky log, replace or rebuild with rock & backfill with dirt.
7	30% section of trail for 40 m = fall line. moderate erosion, monitor and consider realignment if impact becomes egregious. difficult to install drainage due to sustained grade, could install jump or TTF. significant alluvial deposition observed. monitor
8	water run off from rock slab causing erosion and trenching at Heckle rock run out, 40% grade. consider realignment to create drainage using rolling contour/cascading DH design. RR flagged.

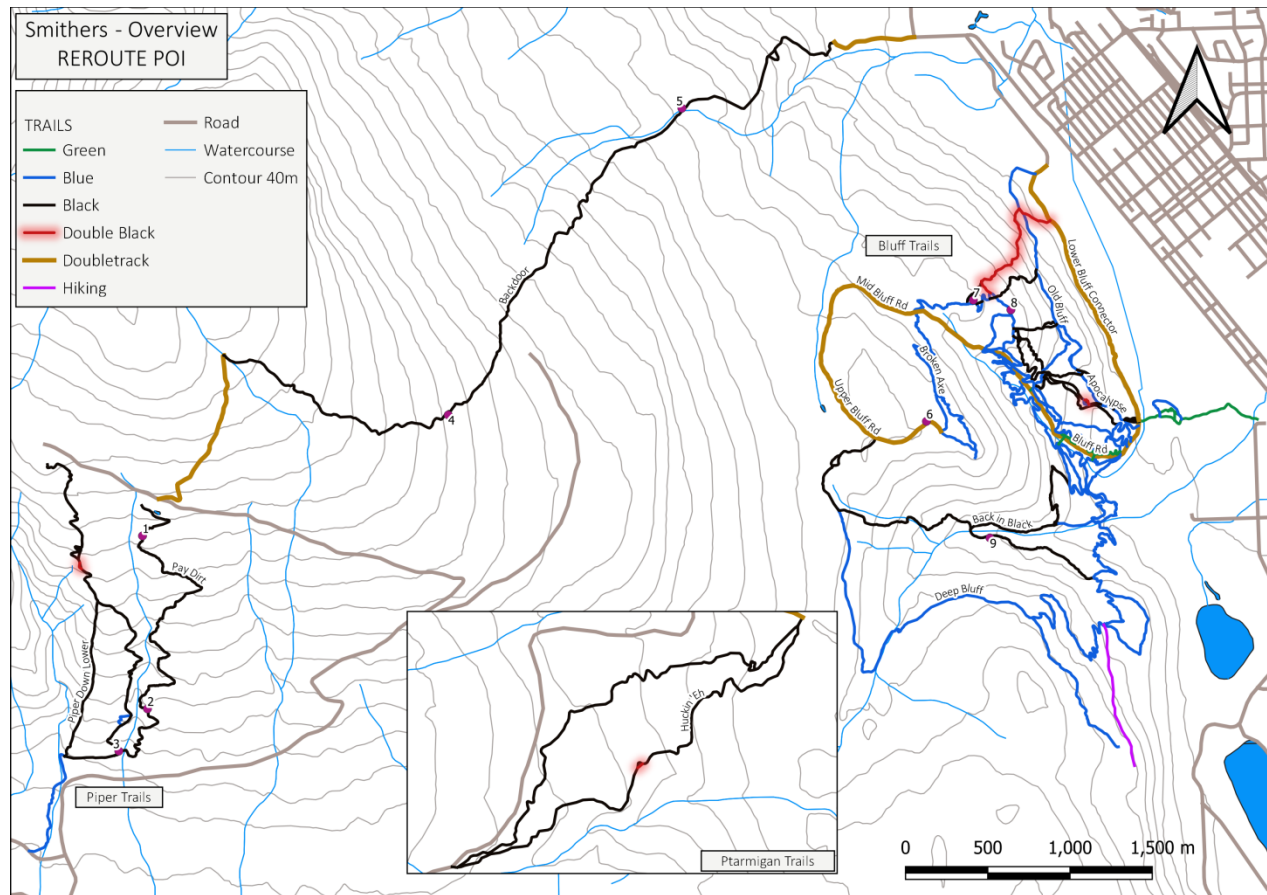
REROUTE POI

POI	DESCRIPTION
1	reroute of eroded trail section should be considered to improve long term sustainability. Approx 200m.
2	reroute of eroded trail section should be considered to improve long term sustainability. Approx 200m.
3	blue ride around for final wood feature recommended. approx 50-75m of trail could be constructed by hand to create an easy bypass. may require wood feature to descend road cut and ditch.
4	seepage and water coursing down trail 25m. realign approx 45m. requires 15m boardwalk to span ski run/saturated soils after reroute. divert water from seep off trail above where rr rejoins existing trail.
5	option to realign trail to cross creek on FSR vs rebuild large bridge. 5m low bridge required or simply ride through cobble creek bed on FSR. reroute 60m section thru forest following pink flagging uphill after crossing.
6	potential to reroute rd section to Deep Bluff, but doubtful it would be used as Upper Bluff road would be more efficient.

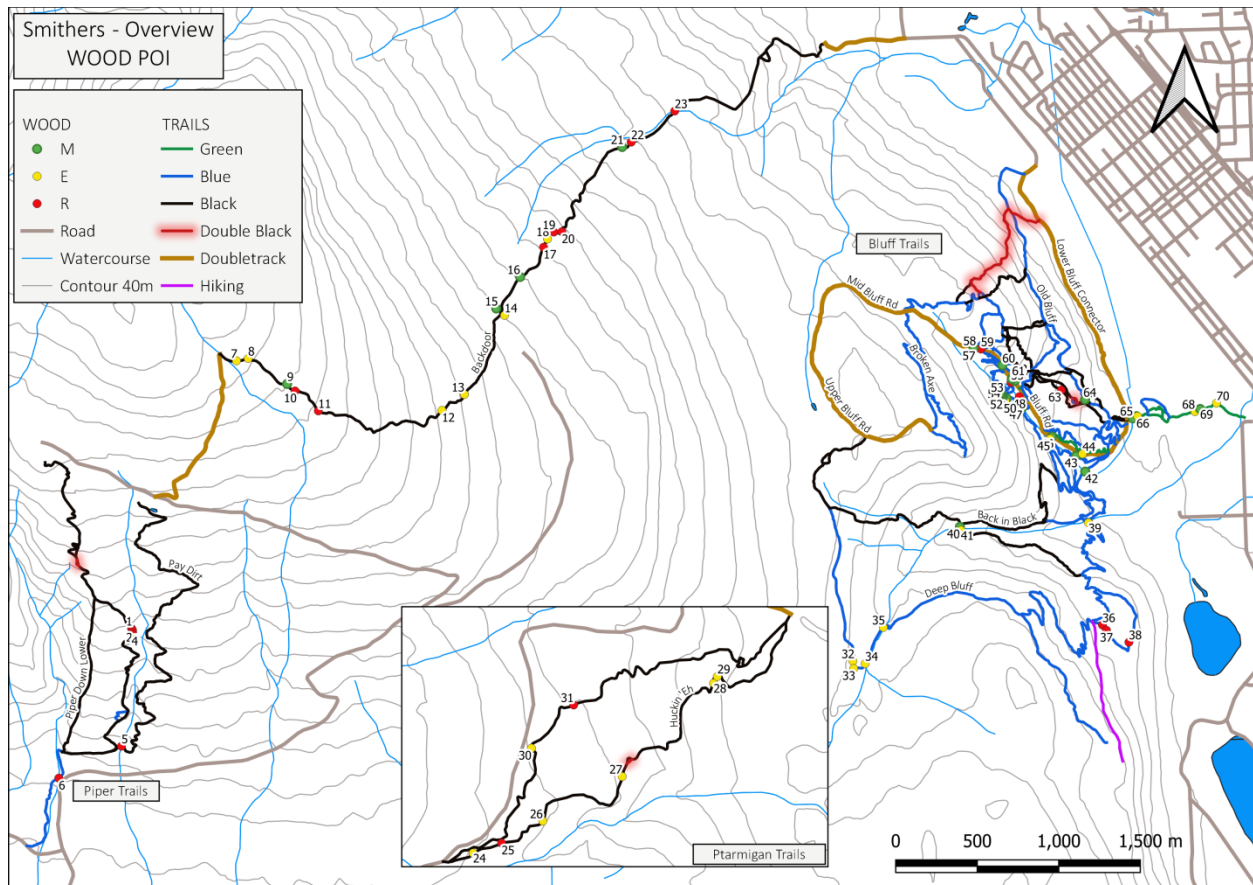
WOOD STRUCTURE POI

POI	MER	DESCRIPTION
1	R	boardwalk. 3.3m L x 0.8m W. rotten decking/stringers. could be replaced with culvert R
2	R	boardwalk. 1.3 m L x 0.8m W. rot in decking. could be replaced with culvert. R
3	R	boardwalk. 1.6m L x 1.0m W. rotten. could be replaced with culvert. R
4	R	boardwalk. 1.6m L x 1.0m W, rotten. could be replaced with culvert. R
5	R	bridge 5m L x 2.5 m W. decrepit. R
6	R	bridge 21.3m L x 1.1m W x 2.1 H. bark on stringers. rot in bracing and supports. excessive gap in deck. R
7	E	boardwalk 2m L x 75cm W. 11cm overhang 4cm gap. sngl nails. aged decking. trim decking, replace in near future. E
8	E	boardwalk 2m L x 75cm W. 15cm overhang 4cm gap. sngl nails. aged decking. trim decking. replace in near future. E
9	M	boardwalk 1.2m L X 70cm W. 1/3 buried. M
10	R	boardwalk 1.9m L x 67cm W. decrepit. R
11	R	boardwalk 16m L x 60cm W. decrepit. R
12	E	skinny 2.5m L x 25cm W. requires tractioning which has become unaffixed. E

13	E	bridge. 4m L x 90cm W. 4cm gap 6cm overhang. E
14	E	bridge 2.8m L x 1.2m W. gap 6cm overhang 15cm. trim overhang. E
15	M	bridge 4.5m L x 1.2m W. gap 3cm overhang 5 cm. M
16	M	boardwalk 3.5m L x 85cm W. no gap, no overhang. M
17	R	boardwalk. 2.0m L x 0.75m W. rotten stringers and deck. R
18	E	boardwalk. 3.5m L x 0.75m W. cedar. stringers and decking good. consider replacement of decking due to thin planks currently. E
19	R	elevated boardwalk with down ramp. 26m L x 0.75m W x 1.2m H. 45% down ramp. expiring stringers, rotten aged decking/broken boards, rotten supports. R
20	R	boardwalk. 4.1m L x 0.85m W. rotten deck, half log stringers with bark, exposed nails, broken decking. R
21	M	bridge. 4.8m L x 1.2m W x 0.75m H. sound. M
22	R	log bridge. single log 1.2m L x 0.2m W. rotten. consider replacement with boardwalk or culvert - determine during next freshet. R
23	R	bridge. 16m L x 1.5m W x 2.2m H. 45% slope into bridge = high speed. trestles and stringers bark on, rot found in posts & sills. decking exceeds overhang and spacing. requires new decking or added stringers to support overhang. R

24	E	boardwalk 2.4m L x 0.85m W. 20cm deck overhang - trimming would be too narrow, consider rebuild. E
25	R	boardwalk 4.2m L x 1m W. 16cm overhang does not comply. required: trim decking, adjust spacing, dbl nail deck. rotten sills, replace. replace entire structure in future. R
26	E	boardwalk 12m L x 1.1m W. 15cm overhang - trim decking and adjust gaps, dbl nail decking. rot beginning in stringers. replace where rot in decking. replace in future. E
27	E	bridge 14m H x 1.2m W x 2.1m H. sound construction, decking and overhang do not comply. width is appropriate for trail speed and height - add supports for overhang to comply with WTS. requires retainer and backfill at exit due to sloughing. E
28	E	boardwalk 2.45m L x 1.22m W. 16cm overhang does not comply. width reqd because of trail speed. rot in end of stringer. Replace in future. E
29	E	bridge 9.5m L x 1.22m W. overhang exceeds max allowed but is reqd due to rider speed. add stringer to support overhang or widen stance of stringers. E

30	E	boardwalk. 22.5 m L x 1.2m W. spacing and overhang do not comply. crossbracing/post supports reqd to eliminate wobble throughout. rot beginning in stringers/sill interface at bottom end, replace in future. rot in some decking - replace. E

POI	MER	DESCRIPTION
31	R	boardwalk x2. rot in stringers, some boards are loose/broken. (1) 2.10m L x 1.3m W between rollers. decking, stringers and overhang don't comply. R. (2) 1.25m L x 1.25m W. decking, stringers and overhang don't comply. R
32	E	boardwalk 19m L x 77cm W. 7cm gap, 8cm overhang. sound. trim decking. E
33	E	boardwalk 21m L x 77cm W. 7cm gap 8 cm overhang. sound. trim decking. E
34	E	boardwalk 25m L x 77cm W. 7cm gap 8cm overhang. replace broken decking board, trim decking. E
35	E	bridge. 5m L x 1.2m W. 7cm gap 7cm overhang. trim decking. E
36	R	plank boardwalk. 4.2m L x 70cm W. rotten. R
37	R	Plank bridge. 7m L x 70cm W. prevalent rot. R
38	R	plank bridge. 2.15m L x 60cm W. aged structure, rot prevalent. R
39	E	1) bridge and 2) boardwalk section. 1) 8m L x 1.2 W. add support posts at creek bank edge to minimize deflection of stringers. E 2) 15m L x 1.3m W. 10cm spacing, 30cm overhang. correct spacing and/or redeck. E

40	M	bridge. 7m L x 88cm W. 5cm gap 5 cm overhang. sound. M
41	E	ramp. 6m L x 95cm W. 15cm overhang 8cm gap. support overhang with additional stringer or trim or redeck to comply where required. E
42	M	boardwalk. 3.2m L x 1.0m W x 0.55m H. sound. M
43	M	bridge. 2.8m L x 1.0m W x 1.0m H. Sound. M
44	E	bridge. 1.85m L x 90 cm W. overhang >10cm. trim overhang. E
45	E	bridge. 5.2m L x 0.9m W x 0.9m H. sound stringers. overhang 10cm, gap 4cm. trim overhang. replace decking where rotted. consider adding dirt to end. E
46	M	boardwalk. 1.85m L x 0.9m W. sound. M
47	M	bridge. 3.16 L x 1m W sound. M
48	R	bridge. 2.0m L x 0.75m W. 8cm overhang. drive in loose nails, trim decking. rot in stringer. R
49	M	bridge. 3.15m L x 1.0m W x 0.65m H. sound. M
50	E	boardwalk. 25m L x 0.75m W. stringers sound except entry. replace aged decking/entry stringers; rebuild 5m entry - rot in stringers. add supports to remove deflection where required. E

51	M	new boardwalk. 3.7m L x 1m W. high quality build. M
52	M	new bridge. high quality build. 3.63m L x 1m W. M
53	M	new bridge. high quality build. 3.7m L x 1m W x 0.7m H. M
54	M	new bridge. 3.7 m L x 1m W. M
55	R	bridge 14m L x 1.2m W. x 2 m H. rot in entry stringer. tilted decking, gaps 5cm, overhang 17cm. rot in support posts, bark on. hazard in wet. R
56	M	bridge. 1.57m L x 1 m W. M
57	M	bridge. 1.75m L x 1.0m W x 0.4m H. sound. M
58	M	boardwalk. 1.7 L x 1m H. M
59	R	bridge. 1.4m L x 0.9 W x 0.25m H. aged, rot in decking. R
60	M	bridge. 1.7m L x 1.0m W x 0.5m H. sound. M

POI	MER	DESCRIPTION
61	M	bridge. 1.5m L x 1.0m W x 0.5m H. sound. M
62	M	bridge 3.1 m L x 1m W. M
63	R	boardwalk. 2.4m L x 1.2m W. decking and overhang does not comply. covered in tractioning. aged, significant deflection/not anchored. remove and fill with dirt and rock or rebuild. R
64	M	boardwalk 2.5m L x 65cm W. gap 5cm. M
65	M	bridge. 3.55m L x 1.0m W x 0.4m H. sound. M
66	M	bridge 2.95m L x 1.0m W x 0.6m H. sound. M
67	E	boardwalk. 5.6m L x 0.78m W x 0.25m H. 15cm overhang x 7cm spacing. decking needs 2 nails per side and some pieces are not secure. recommend adjust spacing and decking to meet standard or redeck or rebuild. E
68	E	bridge. 4.1 m L x 1.47m W x 0.9m H. requires 2 nails per side. E
69	M	bridge. 3.75 m L x 1.5 m W x 0.8m H. M
70	E	bridge. 7.5m L x 1.5m W x 1.2m H. overhang >15cm gap 5cm. trim decking. middle supports not effective but no deflection on high quality stringers. single nails, requires two per side. E

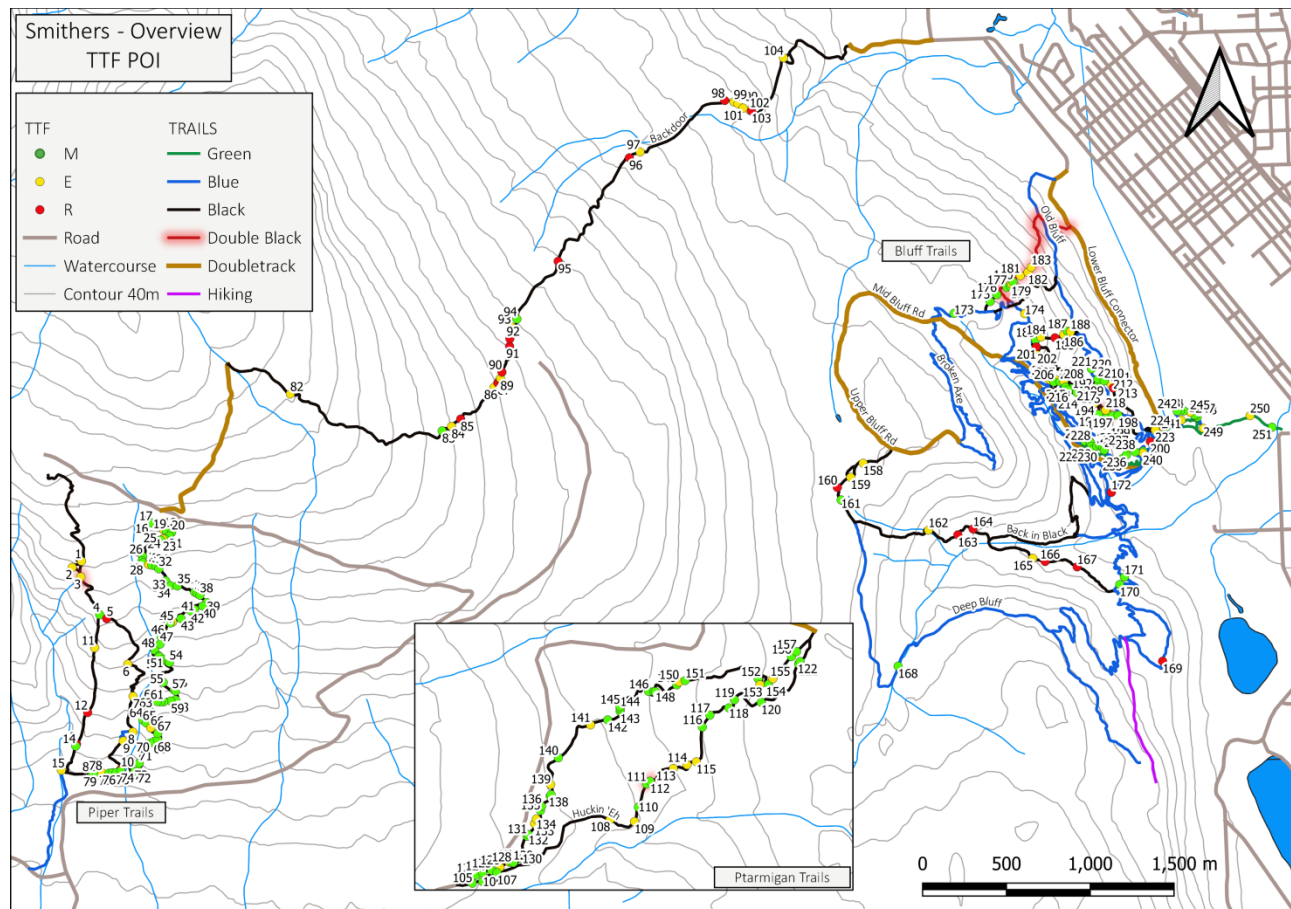
TTF POI

POI	MER	DESCRIPTION
1	E	Rock slab/garden (1) main option - 40m of 55% rock slab with 0.4m rollable drops into 75% technical rocky exit. replace rotten crib log at trail merge. Blk. E (2) Alt option. 75% x 8m into fall line straightaway x 75m. Blk. M
2	E	cribbing log, drop 35cm. aged, replace in future. remove stump in outrun, currently an exposed pedal grabber. crib retainer in outrun is rotten, replace. blue. E
3	E	wood ramp gap to wood landing over plane. (1) wood ramp 8.5m L x 0.9m W x 2.5m H. backfill entry with dirt. (2) 3.3m gap to wood landing 3.6m L x 1.5m W. dbl blk. see signage POI for Alt Route. Unify signage at site - potential confusion. E
4	M	rock slab 70% for 6m. blk. M
5	R	skinny 25cm w x 2.5m l. located at high speed exit from rock slab. recommend removal and backfill with dirt or wider boardwalk/wood slab if slope drainage needs accommodated - too narrow for trail speed. R
6	E	skinny. off main line - main flow bypasses. 15.5m L x 0.25m W x 1.5m H. aged entry has rot, replace. deflection in log ride - consider post support to stabilize. consider tractioning. H to W is dbl blk - requires TTF warning sign. E

14	M	drop 85cm h. milled wood entry. consider tractioning/resurfacing. M
15	E	wallride. 16m l x 3.5m h 50°. bracing and decking needs reaffixed in spots. overhang needs trimmed. recommend thicker boards for cross bracing in places. tractioning recommended. aged, consider rebuild in future. E
16	M	table top. 0.35m H x 3.5m L. blue. M
17	M	table top. 0.7m H x 4.0m L. black. M
18	E	tabletop. 0.45m H x 3.5m L. remove large pile of dirt in run-out. blue. E
19	M	hip jump. 0.7m H x 3.0m L. black. M
20	M	double, rollable. 25cm H x 4.0m L. Blue. M
21	M	tabletop. 0.5m H x 4m L. blue. M
22	M	tabletop. 0.6m H x 3.5m L. blue. M
23	E	double, rollable but somewhat abrupt at trail speed. 0.3m H x 4.0m L. recommend fill to keep consistent with other tabletop jumps or remove or make less abrupt. blue. E
24	M	tabletop. 0.70m H x 4.0m L. black. M
25	M	tabletop. 0.5m H x 4.0m L. blue. M
26	M	tabletop. 0.45m H x 4.5m L. blue. M
